ControlLogix DeviceNet Interface Module

Catalog Numbers 1756-DNB, Series C and D

Publication 1756-RN660C-EN-P - February 2011

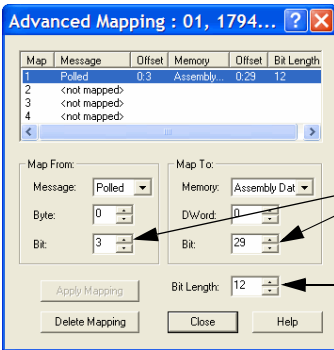
Corrected Anomaly	Description
Data value of -273817920 (0xEFADDEC0) appeared in controller input tag	<p>CORRECTED: When the connection from the Logix controller to the 1756-DNB series C module was reestablished, the data in the input tag for the 1756-DNB module was invalid until the first input packet was received from any node on the DeviceNet network in the 1756-DNB scan list. If the connection was reestablished after the 1756-DNB module was power cycled, a data value of -273817920 (0xEFADDEC0) appeared in the input tag until the first input packet was received.</p> <p style="text-align: right;">Lgx00082315</p>
Module faulted when using Advanced Mapping	<p>CORRECTED: The 1756-DNB module faulted when using Advanced Mapping for the Input Table or Output Table, with bit offsets or data sizes that are not multiples of 8 bits.</p> <div style="text-align: center;">
